## RECOVERING CONTAMINATED SOILS THROUGH PHYTOMANAGEMENT IN SOUTHWEST EUROPE

# Product 2.1/E.2.1.1 Phy2Sudoe network enlargement - Characterization of new sites

Activity 2.1/ Deliverable E.2.1.1 Characterization of new sites integrated to the "Network of phytomanaged sites in the SUDOE region", to add new case studies and phytomanagement strategies

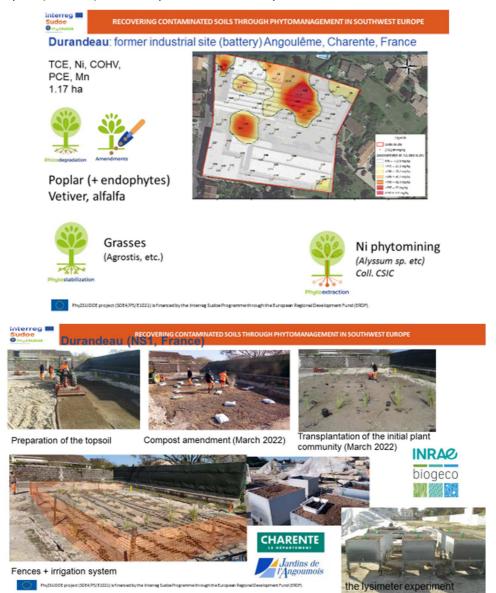
Set up of the Durandeau site in March 2022 (© Dudoit La Charente /Mench INRAE)

• Implementation: organic and inorganic contaminants were firstly assessed by La Charente (and HPC Environtec) in soil and subsoil on the whole site and mapped. Then the concrete slab was removed in March 2022 on roughly 200 m<sup>2</sup> under the supervision of La Charente and HPC-Envirotec. Thereafter the 0 – 0.50 m soil layer was loosened. This area displayed high metal(loid), PAH, PCB, and trichloroethylene concentrations in the topsoil. Based on previous pot experiments carried out by INRAE, compost (5% w/w) was incorporated into the topsoil.

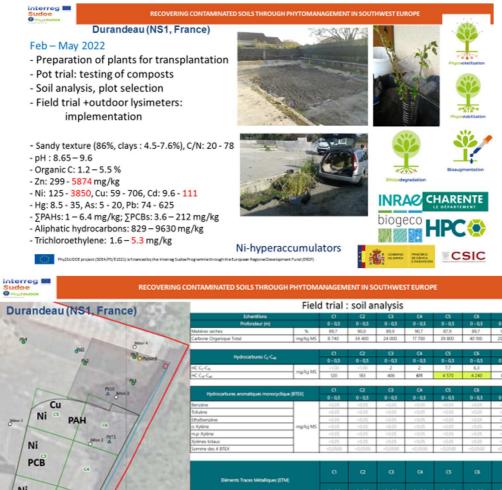
Soil contaminants in the Durandeau site © La Charente

• soil properties: this alkaline technosol displays a soil contamination by metal(loid)s (notably Zn, Ni, Cu and Cd in excess) and organic compounds, listed in the following tables:

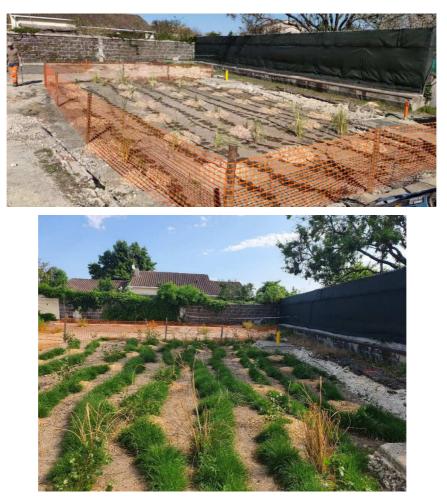
The field trial implemented at Durandeau site in May 2022 (© Jardins de l'Angoumois)

- Poplars, willows, and grassy species implemented in a field plot by the Charente County and INRAE partners are successfully developing and limiting the pollutant linkages. No metallophyte colonists were present. Rate of vegetation cover was close to 80% with only some bare soil remaining between the pipes of the irrigation system. Mortality rate was roughly 0% (with only one died poplar replaced, being damaged by the wind).

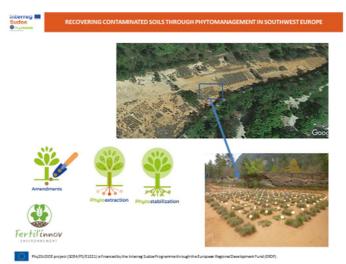
Focus on field plots at Les Avinières site © Fertil'innove Environnement

*In situ* tests were set up at the end of 2019 before proceeding with the rehabilitation of the old mine to confirm the effectiveness of the supply of organic matter and optimize the association of the various plant and microbial species. The pilot tests made it possible to define the phytostabilization protocol for Les Avinières:

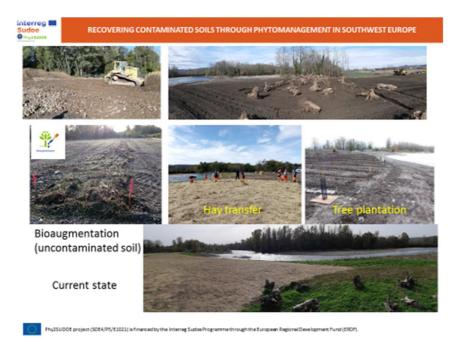
Implementation of the green capping; bioaugmentation with soil and hay transfer, transplantation of local trees © CD64 /Bordes town, Suez Lyre

Plant species used: Festuca rubra, Trisetum flavescens, Anthoxanthum odoratum, Poa pratensis, Trifolium pratensis, Vicia sepium, Silene vulgaris, Plantago lanceolata, Holcus lanatus, and Agrostis capillaris

Tree species: *Fraxnus excelsior, Acer platanoides, Sorbus torminalis, Alnus glutinosa, Corylus avellana, Salix caprea,* and *Salix viminalis.*

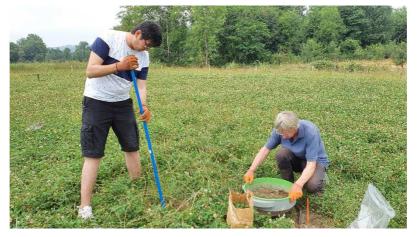
Screening of plant community and soil sampling to investigate microbial community at the Bordes site © Mench/INRAE - CD64

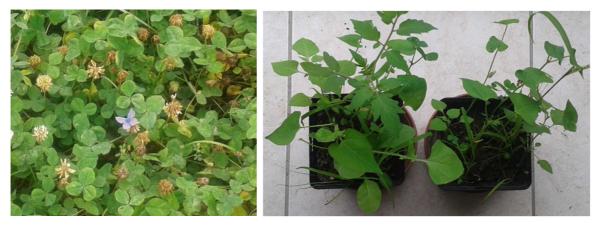
Butterfly on white clover on site and study of seed banks and soil phytotoxicity for the Bordes site  $\ensuremath{\mathbb{C}}$  Mench/INRAE

- Soil seed banks displayed a relatively high biodiversity for 5 out of 6 contaminated soils collected at 6 different plots.

- The addition of compost stimulated the plant growth and the diversity of the plant community.

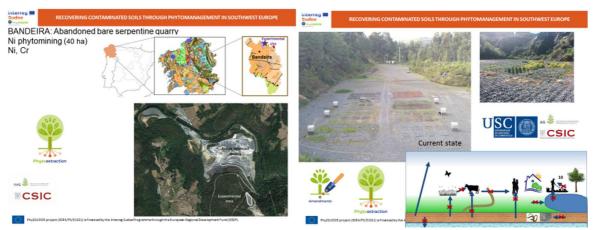
Location, field trial and conceptual model for the Bandeira site  $\ensuremath{\mathbb{C}}$  CSIC-USC

• implementation: This site is an abandoned bare serpentine quarry (40 ha) in Galicia. It is located in the Melide-Serra do Careón geological complex, which represents one of the three main serpentine outcrops of the Iberian Peninsula. It is characterised climatically by a high precipitation (annual mean 1375 mm) and mild temperatures (annual mean 12.6 °C). The active opencast mine is embedded in a substrate of amphibolites and serpentines, covering an area of 40 ha and is dedicated to the extraction of serpentinised peridotite for the production of gravel for construction and ballast for railway tracks. The generated sterile material is accumulated in spoil heaps and these cover an area of around 3.4 km<sup>2</sup>.

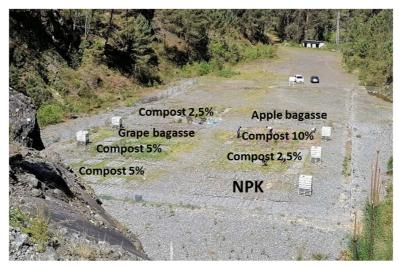
Field trial at the Bandeira site, Spain (© B. Rodriguez et al., CSIC)

Since January 2022, dead individuals were replaced in plots established in 2021. New plots were planted with *B. emarginata* and *B. tymphaea*. Attention was focused on areas with 2.5% and 5% of compost. About 300 new seedlings were established.

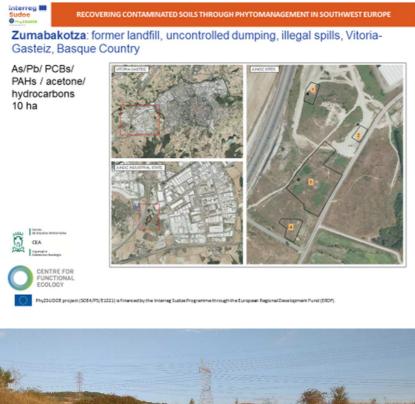
Pict. 7.1. Site cleaning setting aside residues (asphalt) and inert material (@Vilela, CEA)

- Preliminary cleaning: due to the state of abandonment and degradation of the plots, it was necessary to remove manually and with machinery numerous debris and garbage items.

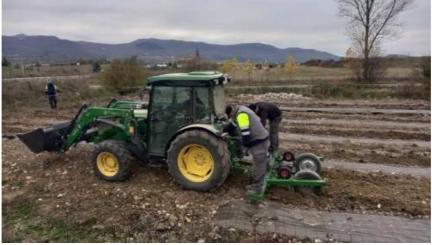
Pict.7.2. Site preparation for poplar/willow stands (@Vilela, CEA)

- An organic amendment was applied with sewage sludge and shredded pruning (using an approximate dose of 100 t/ha).

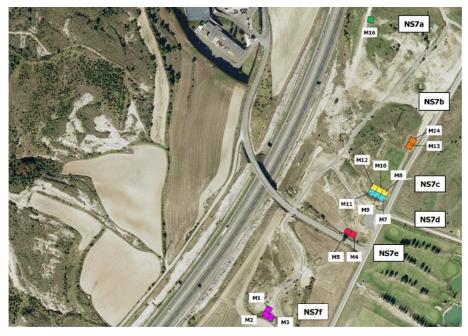
Pic. 7.3. NS7 plots and monitoring subplots (@Vilela, CEA)

CEA evaluates changes in pollutant linkages on the site associated with the phytomanagement options, especially CEA is monitoring the contamination reduction on each treatment.

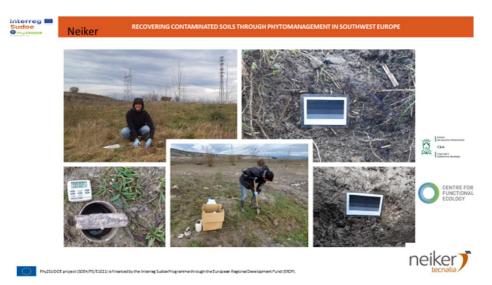
In situ assessment of soil quality with Soil Cards at the Zumabakotxa site © Neiker/ CEA

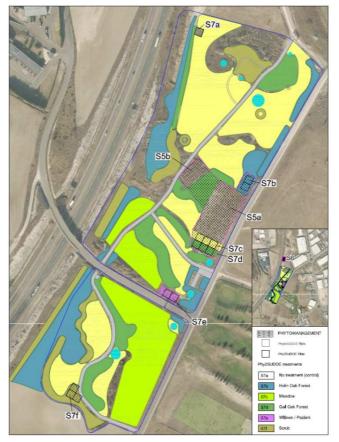
Pic. 7.2. Site planting plan and Phy2Sudoe plots (@Vilela, CEA)

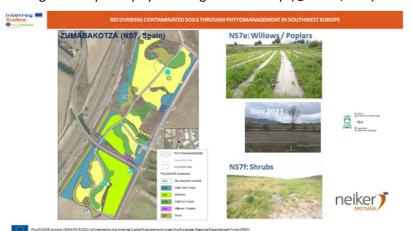
Fig. 7.3 Map and phytomanagement set-up (@Vilela, CEA)

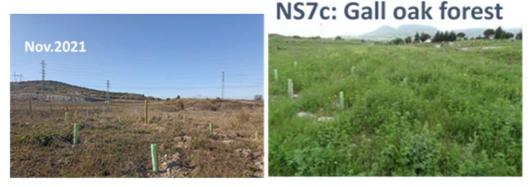
Field trials at Zumabakotxa, Spain (© J Vilela et al., CEA)

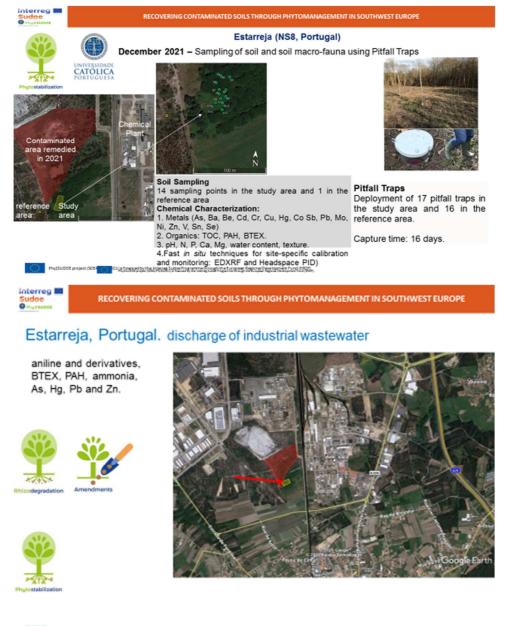
Assessment of physico-chemical and biological properties at the Estarreja site © UCP

Sampling of soil and soil macro-fauna using Pitfall traps were carried out. 14 sampling points were assessed in the study area and 1 in the reference area. 16 bait lamina were deployed at each soil sampling point and 20 in the reference sampling point. The bait-lamina test is an in situ method intended to evaluate the feeding activity of soil organisms.

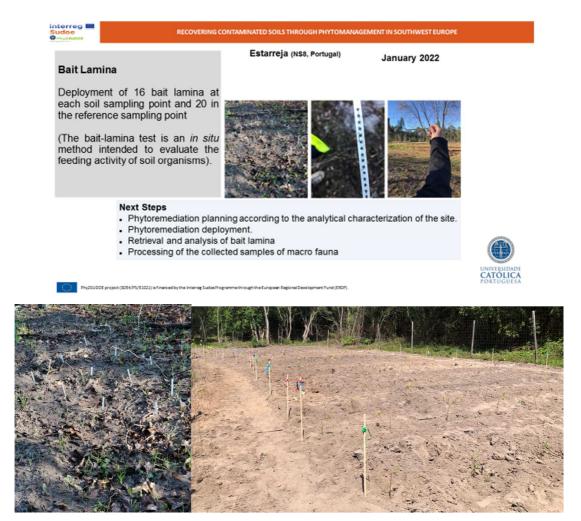
Deployment of bait-lamina and field trial at the Estarreja site (© UCP)

Sampling of soil and soil macro-fauna using Pitfall traps were carried out. The bait-lamina test was used as an in situ method intended to evaluate the feeding activity of soil organisms in the plot topsoils. Poplars and willows, with and without mycorrhizae and hydrogel, and vetiver (intercropped with poplar) were implemented in an irrigated field trial.

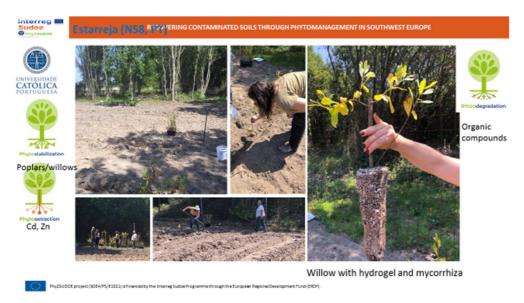
Transplantation of mycorrhizal willows at the Estarreja site © UCP
